# Assessment of Surface Water Quality in Kakanda: Detection of Pollution from Mining Activities

The study focuses on the assessment of the surface water quality of the mining city of Kakanda (Lualaba Province in the DRC) to highlight pollution from mining activity. In addition to literature research, the identification of mining activities and the location of rivers and streams, the methodology adopted consisted in analyzing the water upstream and downstream of different discharge points of final effluents. The choice of parameters was made according to the Congolese legislation on this subject. Field observations indicated that liquid effluents from mining plants are discharged into the natural environment through drains. Chemical analyses have shown that the waters of these drains are loaded with metals at concentrations tens of times higher than standards. The results of the physicochemical analyses also indicated a deterioration of the quality of the water downstream of the discharge points. The level of suspended solids reaches 182 mg/l for an acceptable level of 80 mg/l. The concentration of cobalt and manganese in the streams receiving the final effluents reaches, respectiv

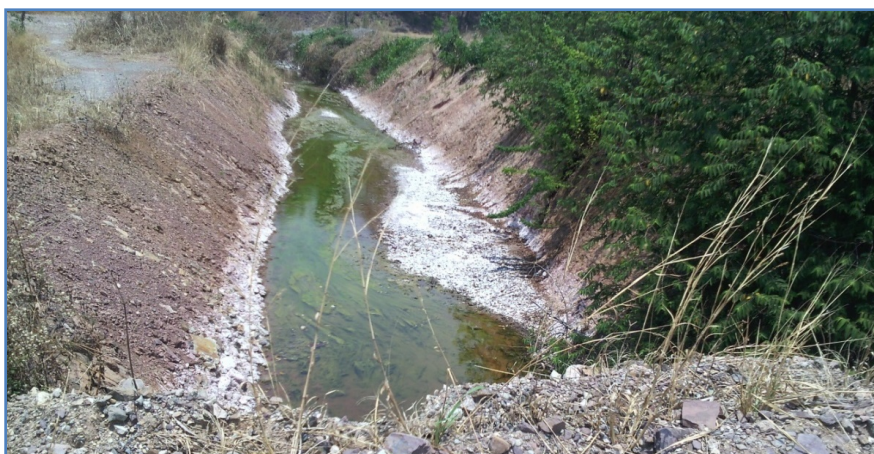
The field observations (see photo of **Figure 2**) show that there is a pinkish deposit that forms on the banks of the drain drains Luita factory. The pinkish coloring refers to the saturation of cobalt waters because the cobalt ions have the pink color in solution.

**Figure 2.** View of a liquid effluent drain from the Luita plant.

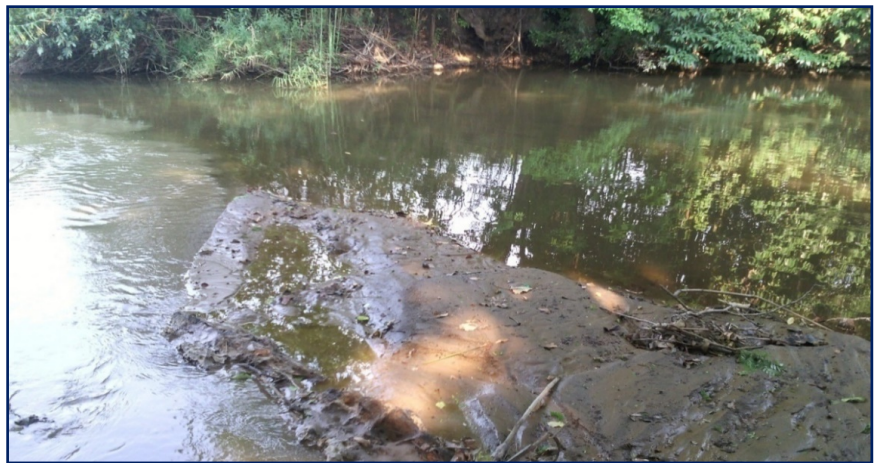
**Figure 3.** View of build-up of Sediments at the Kakanda river water discharge point in the Dikuluwe river.

S3 and S8 to S12). Sediments collected in the Kakanda River at far distance after the different mixing points (S8) have a copper concentration which reaches the threshold above 1%. This indicates that these sediments are indeed of mining origin.

Field observations also show sediment accumulation at the Kakanda River water discharge point in the Dikuluwe River (photo in **Figure 3**). The Kakanda River is the outlet for various waters generated by Kakanda's mining activities. This highlights that this pollution is of mining activities origin.

It is therefore recommended that mining operators based in Kakanda implement good environmental practices as requested by Congolese legislation; because the pollutants identified here (Mn, Cu and Co) have a detrimental effect on the environment and the health of the population [13] [14] [15].
