**Survey of the Village and Carved Rocks of Orongo, Easter Island, by the  
Mana Expedition.**

Scoresby Routledge

*The Journal of the Royal Anthropological Institute of Great Britain and Ireland*, Vol. 50  
(Jul. - Dec., 1920), 425-451.

SURVEY OF THE VILLAGE AND CARVED ROCKS OF ORONGO,  
EASTER ISLAND, BY THE MANA EXPEDITION.<sup>1</sup>

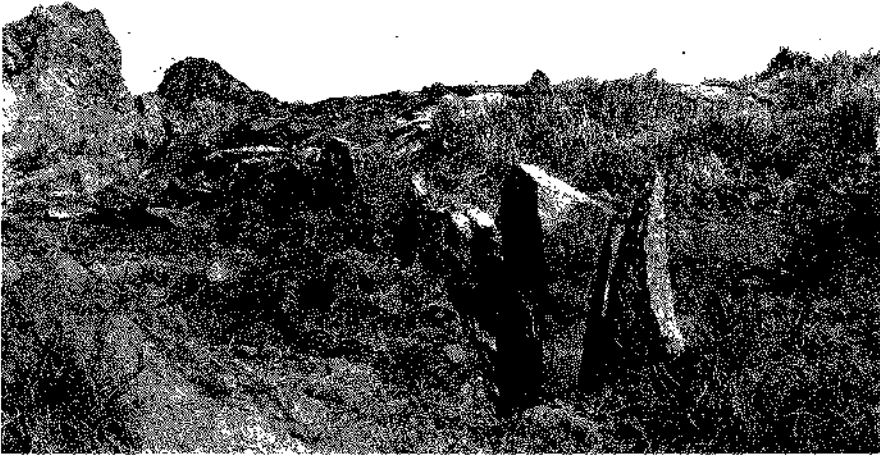
I. EXCAVATION SHOWING CONSTRUCTION OF BACK OF HOUSES.

*The Walls*.—On the inner side of the foundation course, slabs are set up on edge, the largest and flattest sections of stone from the quarry being used for lining the interior and placed vertically (Plate IV, Fig. 2).

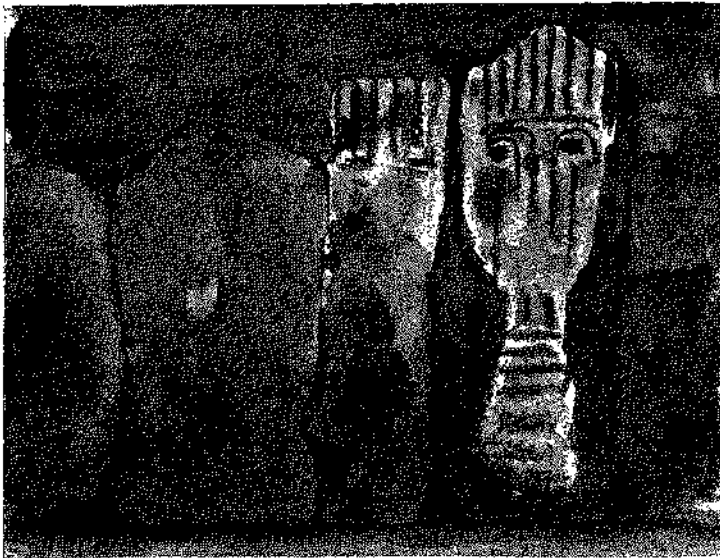
2. PAINTED SLABS (SKETCH).

- I.—Two representations of an *ao*, or ceremonial paddle. No. 26.  
II.—A face adorned with paint; a European ship. No. 6.

Decoration:—two large panels opposite doorway with painted designs. A, a face adorned with paint, red on white ground; B, three-masted ship, black on white ground, with two small figures in rigging, one of them wearing a red shirt (Plate IV, Fig. 2, II). Roof painted white.

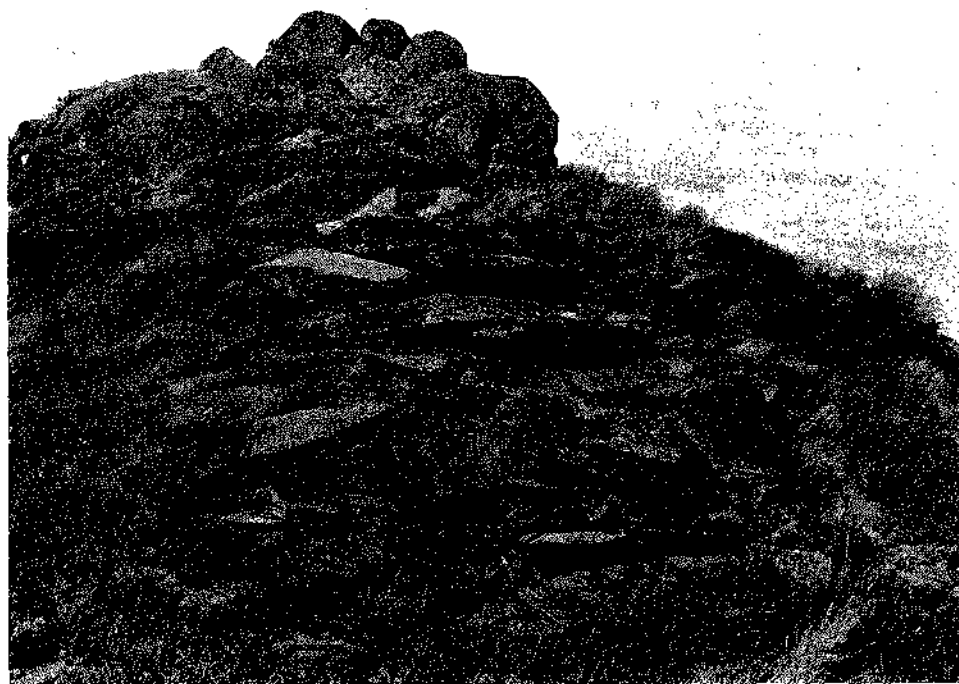
2. CAPSTONES OF HOUSES IN POSITION.

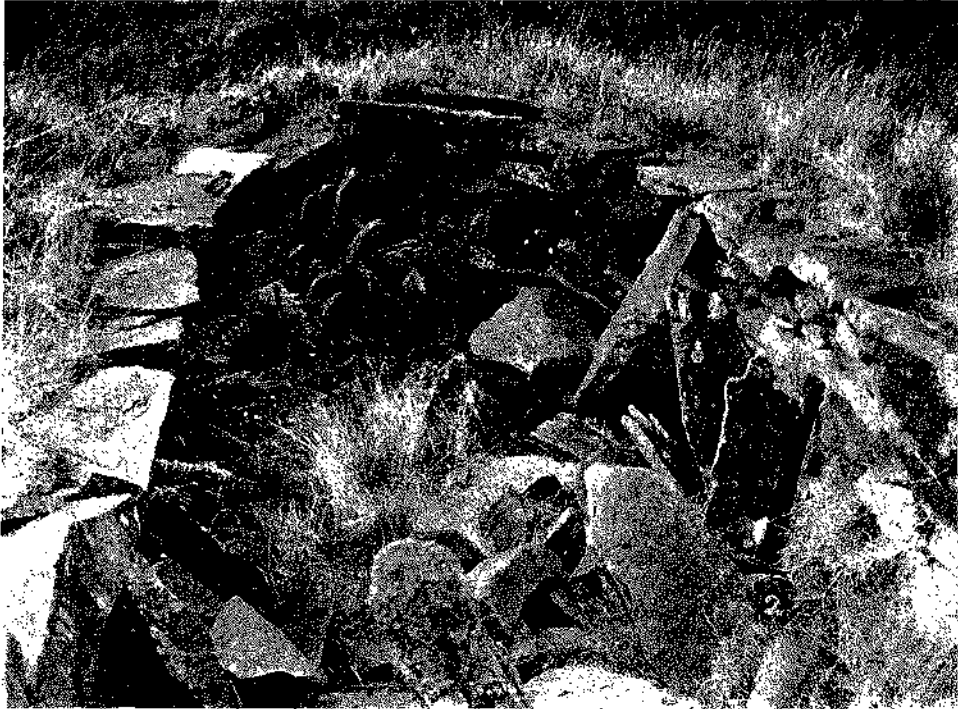
1. END OF A HOUSE UNROOFED. NO. 2.

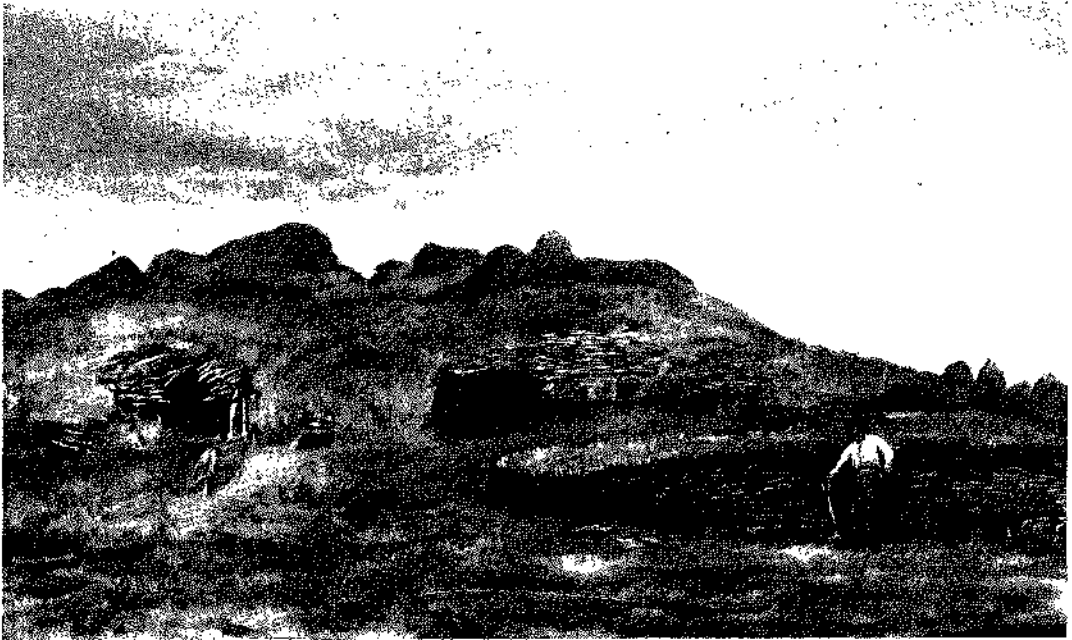
1. CENTRAL HOUSES OF VILLAGE (SKETCH). LEFT TO RIGHT, NOS. 10, 11, 15, 16, 17, 18, AND 22 (DOUBLE ENTRANCE).

The group comprising houses Nos. 10 to 16 (Text-fig. 5; Plate VIII, Fig. 1), forms the most interesting and also the most difficult problem in the village. The following explanation for the position of three houses is put forward, with reserve on certain points.

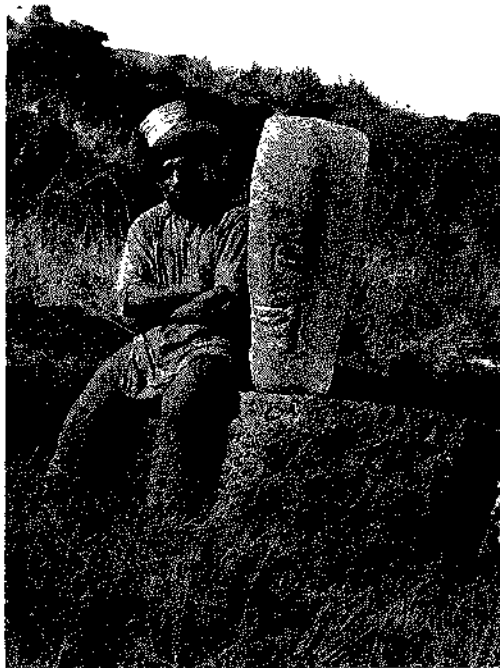
2. DOOR-POST, FORMERLY A FOUNDATION STONE, CARVED WITH FACE.

Also near the line of stones, but on the crater side, were lying the two large stones wrought as foundations for a thatched house, which have been presumed to be the door-posts of No. 11, thrown aside when the house was destroyed. On one of these a face has been carved (Plate VIII, Fig. 2).

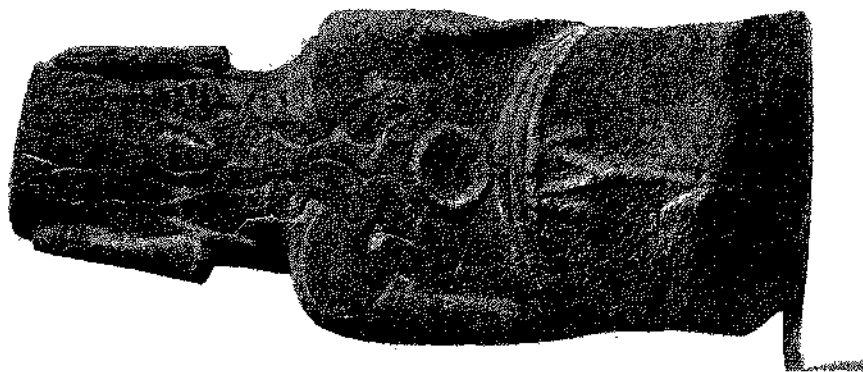
2. STATUE FROM ORONGO, NOW AT BRITISH MUSEUM (BACK), SHOWING RING AND GIRDLE; ALSO FIGURES OF BIRD-MAN, BIRD, *ao*, *rapa*, AND *ko mari*.

A figure of a bird occurs some four times on the rocks, and is found in the decoration of some of the houses; it is also seen on the back of the statue Hoa-hakanaia (Plate IX, Fig. 2). This bird design is always of the same general character as that found painted on the roof of the cannibal cave (Ana kai-tangata).<sup>4</sup> In the

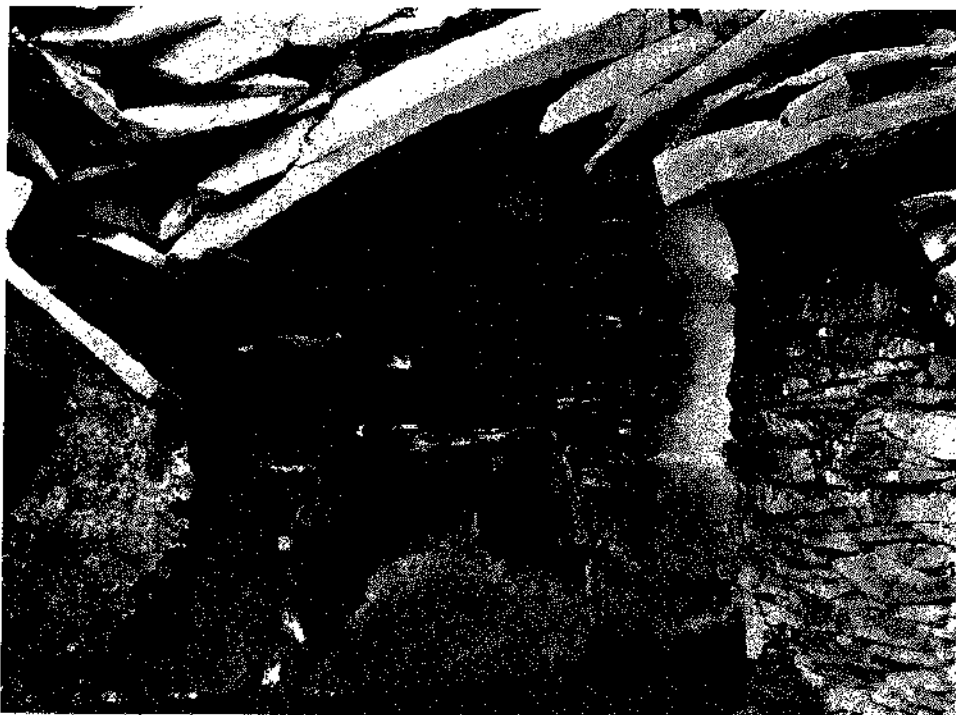
I. HOUSE NO. 11, WHICH CONTAINED THE STATUE.

No. 11 presents a form entirely different from that of any other house. It is a chamber with vertical walls and an almost flat roof. It has one square end, that at the north-west corner, and a rectangular recess at the north-east corner. One end of the roof and one end of the building, those on the south aspect, are entirely missing. The walls are laid bare some six to nine inches below the foundations.

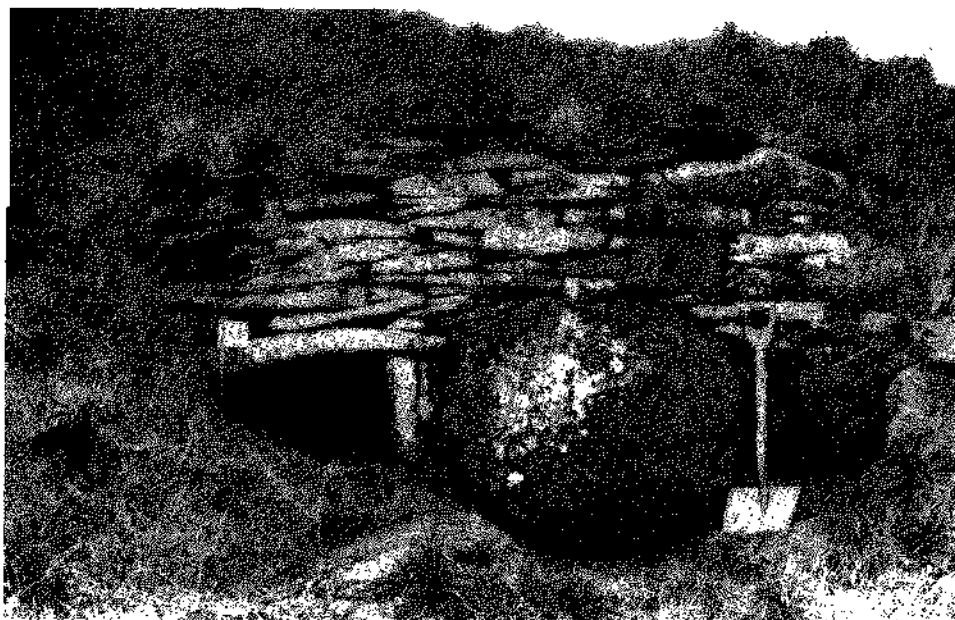
2. HOUSE NO. 18, WITH CIRCULAR STONE, PROBABLY A PEDESTAL.

Not less interesting than the old foundation stones is a circular stone, also of hard basalt, which is built into No. 18, and precisely resembles the bed plates of the images on the *ahu* (Plate X, Fig. 2). Its measurements are 3 feet 5 inches by 2 feet 10 inches, those of the base of the statue, 3 feet by 1 foot 6 inches. The probability seems great that the statue originally stood on it, in the open, in the same manner as the other statues in the island. The only difficulty lies in the contracted form of the base of the image which is not associated with the *ahu*, but with the buried statues. The image is said to have been, before its removal, embedded in the ground, which presumably accounts for the excavated condition in which we found the floor of No. 11. It seems not unlikely, however, that the figure would in any case be sunk when placed in or surrounded by the house, in order to lessen the necessary height of the building.

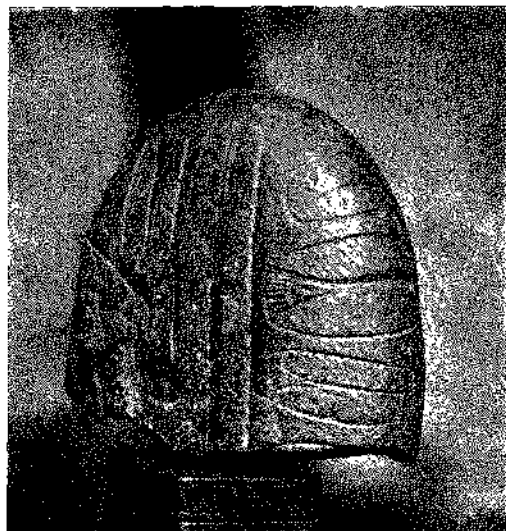
3. PORTION OF A PILLOW STONE, CARVED WITH *ko mavi* FIGURES.

Objects found:—one of the sea boulders which are used as pillow stones (Plate XVI, Fig. 3) and two *mataa* (spear-heads).

Next to the bird-man the most frequent symbol is a small geometrical design said to represent the female sex. It occurs most often on the horizontal rocks or "pavement." It was reported that women of the island, possessed of personal attractions, "fine women," came up to this spot to be immortalized after this manner by professional artists, and that each of these designs represented a particular woman. The symbol is frequently found on pillow stones (Plate XVI, Fig. 3),<sup>1</sup> and elsewhere. Total number on rocks, 49.
